Repair Road Slips at Raccoon Creek State Park

John Jaskolka, P.E.

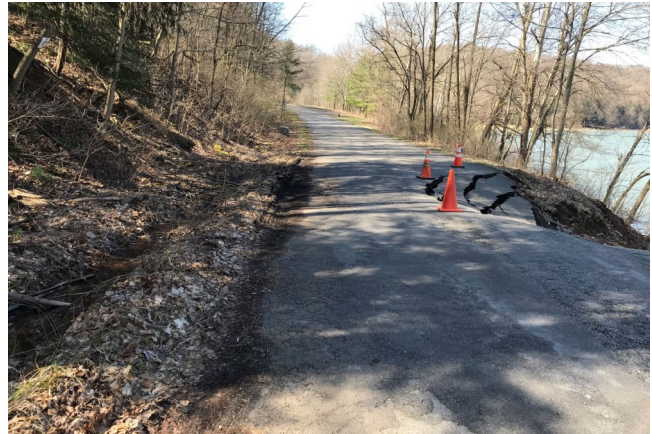
Hill slip along Beach Road.

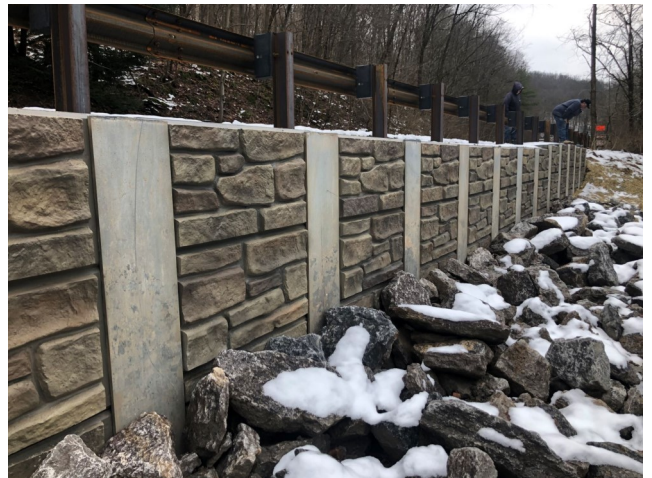
Soldier Pile Wall Construction Completed

the gap. The four slip areas in the park have been recently repaired and the roads are back in full service.
